**PROJECT:** Midnite Mine Remediation**REPORT NO:** 2021-01**OWNER:** Newmont/Dawn Mining**OPERATOR:** Newmont/Dawn Mining**SUMMARY OF WORK ACTIVITIES OR EVENTS FOR THIS REPORTING PERIOD:**

This weekly report provides a summary of Midnite Mine Site (Site) remediation action (RA) construction activities, quality assurance (CQA), quality control (CQC) and engineering activities for the period March 29 – April 1, 2021. The Site activities discussed in this weekly report include, but are not limited to: Site Health, Safety, and Security; Community Liaison, Project Meetings, Regulatory Oversight, Site Visitors; Site Mobilization; RA Activities; Project Documentation; and Site Inspections.

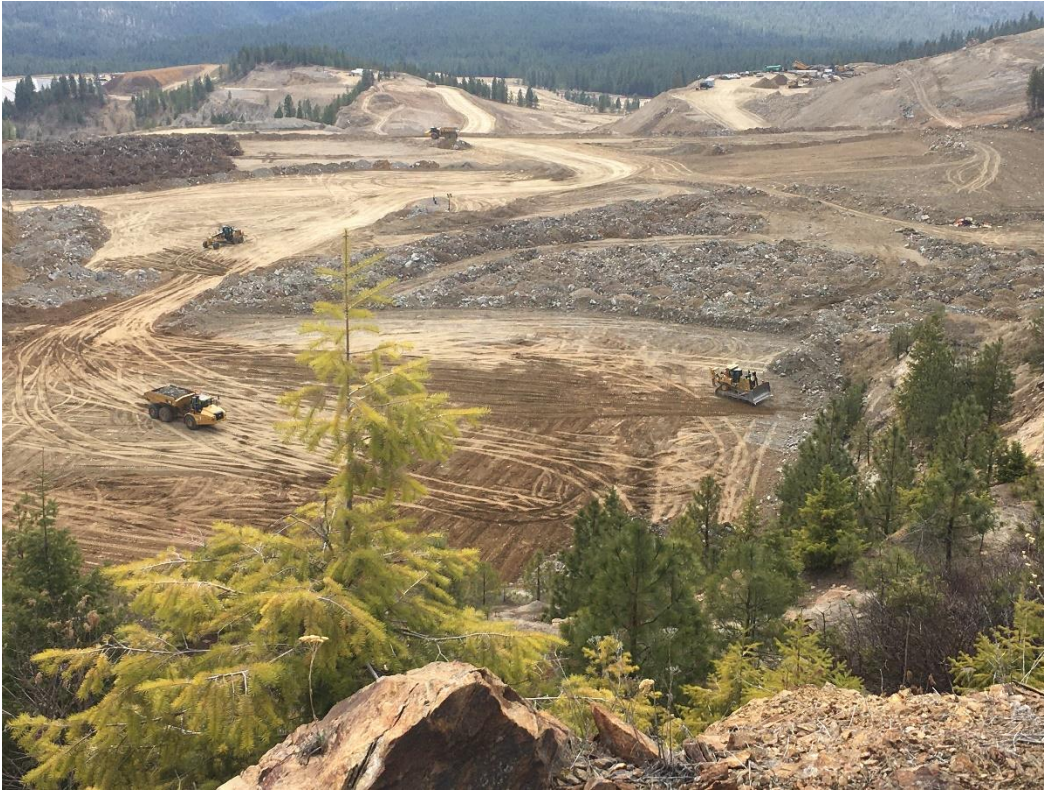
Photo 1 – Material from the SWRP being placed along the west edge of Pit 4.

- Newmont began excavating, hauling and placing low activity/low reactivity material from the west side of the South Waste Rock Pile (SWRP) and high activity/high reactivity material from Ore and Protore Stockpile 4 to Pit 4. Material from the SWRP was placed along the outside perimeter of the Pit 4 Waste Containment Area (WCA) with Stockpile 4 material placed in the middle of the WCA in accordance with the design and specifications. Estimated quantities, based on load counts, are presented in Table 1.

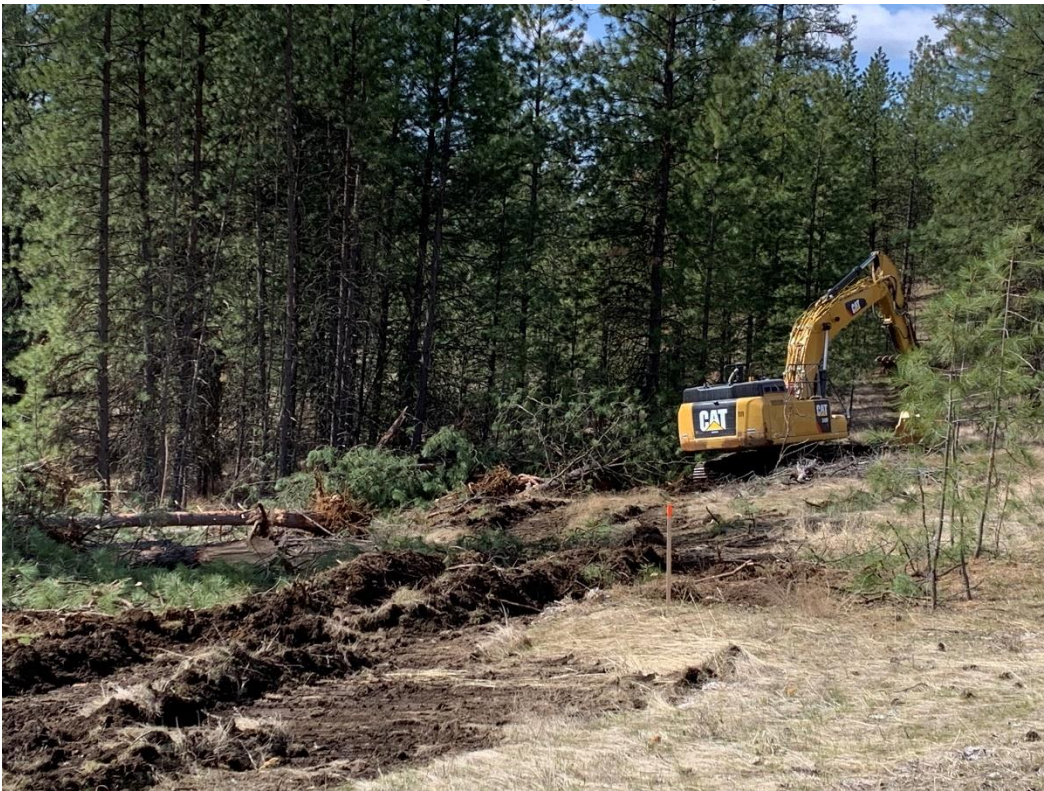
Photo 2 – Removal of trees from the New Topsoil Stockpile. Stake with orange top in the foreground is the design toe of the stockpile.

- Newmont removed timber from the New Topsoil Pile area located south of the South Construction Support Zone (CSZ). Timber was placed around the perimeter of the stockpile area as a Brush Sediment Barrier.

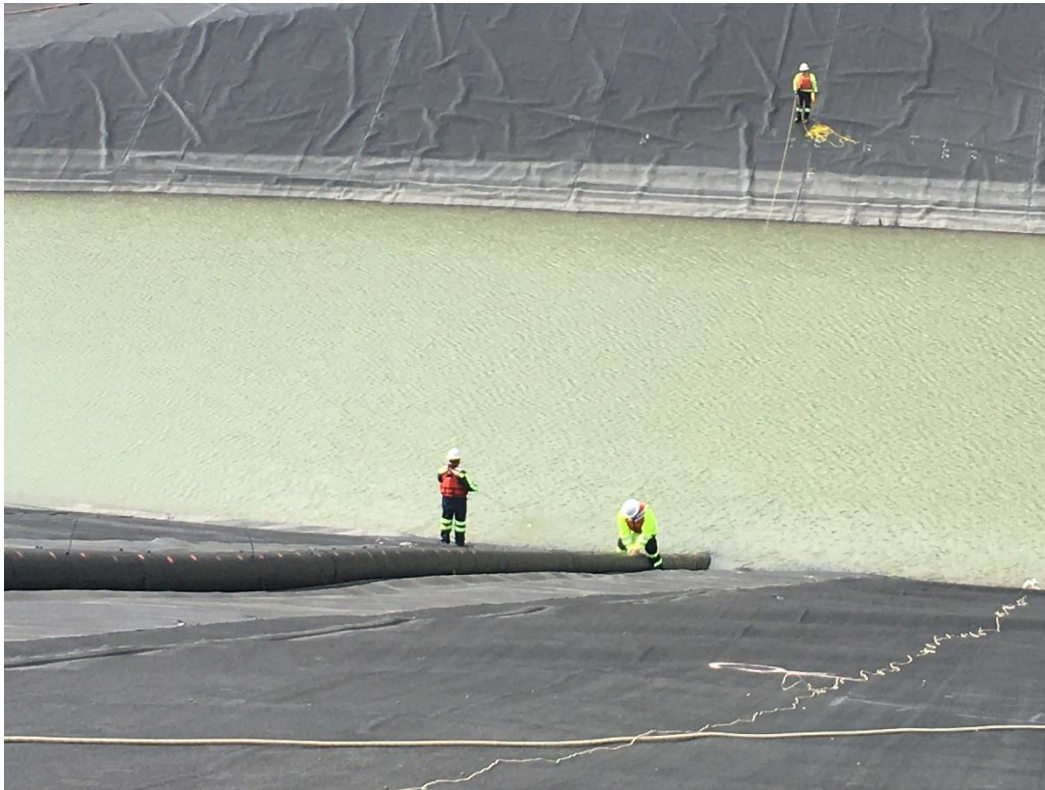
Photo 3 – LLSI with support from Newmont locating leaks in the primary liner of the east cell of the South Pond.

- Leak Location Services Inc (LLSI) performed electronic leak location surveys of the primary liner in the east and west cells of the South Pond. Six potential leak locations were identified in the east cell and three locations were identified in the west cell. Newmont began transferring water from the South Pond to Pit 3 at the completion of the survey.

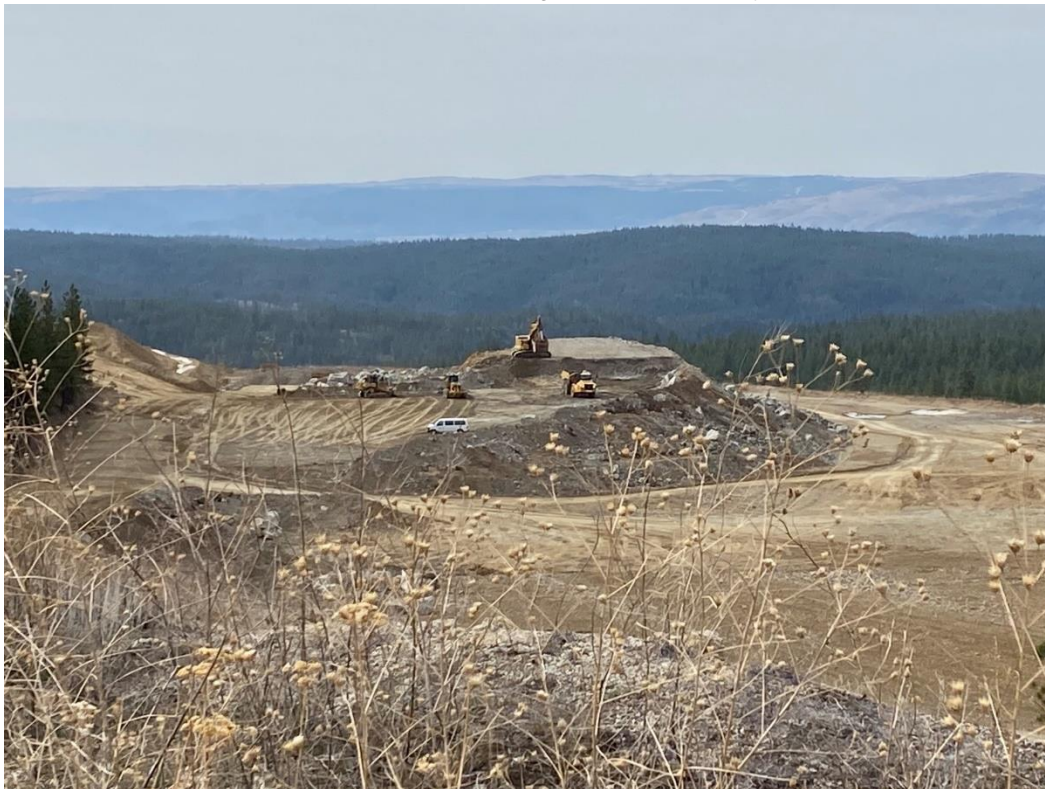
Photo 4 – Caterpillar 390 excavator loading haul trucks at the middle area of the SWRP.

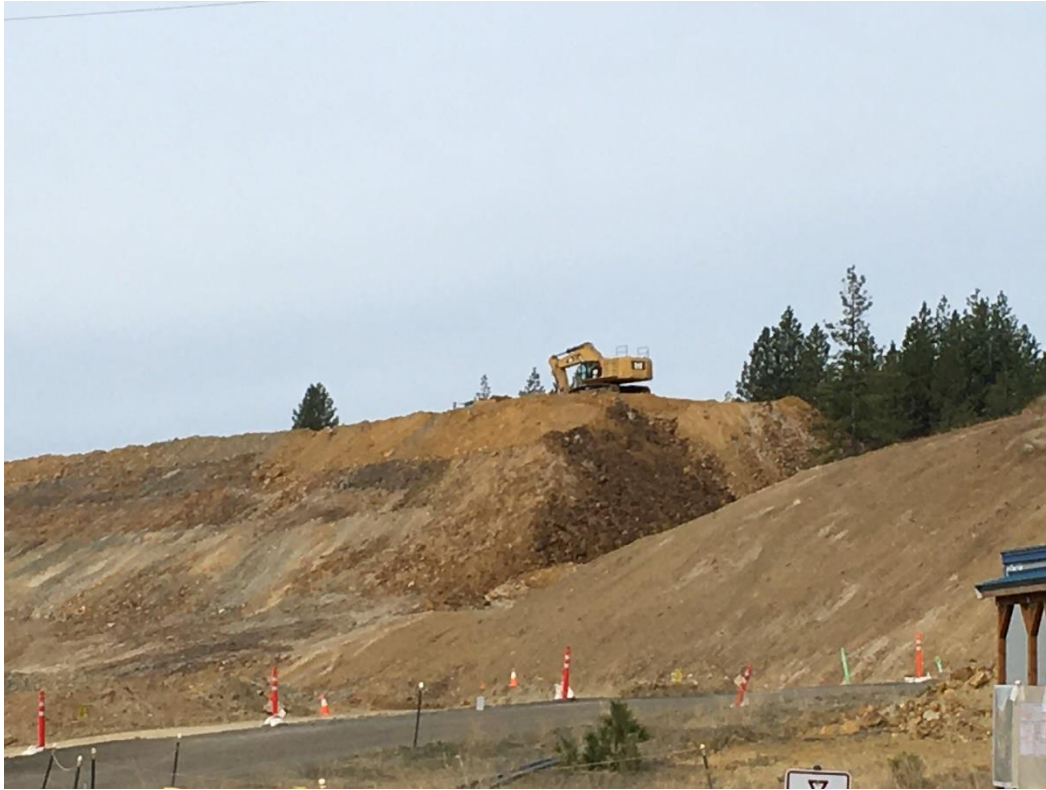
Photo 5 – Caterpillar 390 excavator loading material from Ore and Protore Stockpile 4 for haulage to Pit 4.
